INVESTIGATION OF CHECK
DRAINS DISCHARGING INTO THE
DELTA-MENDOTA CANAL

Central Valley Regional Water Quality Control Board

October 1987

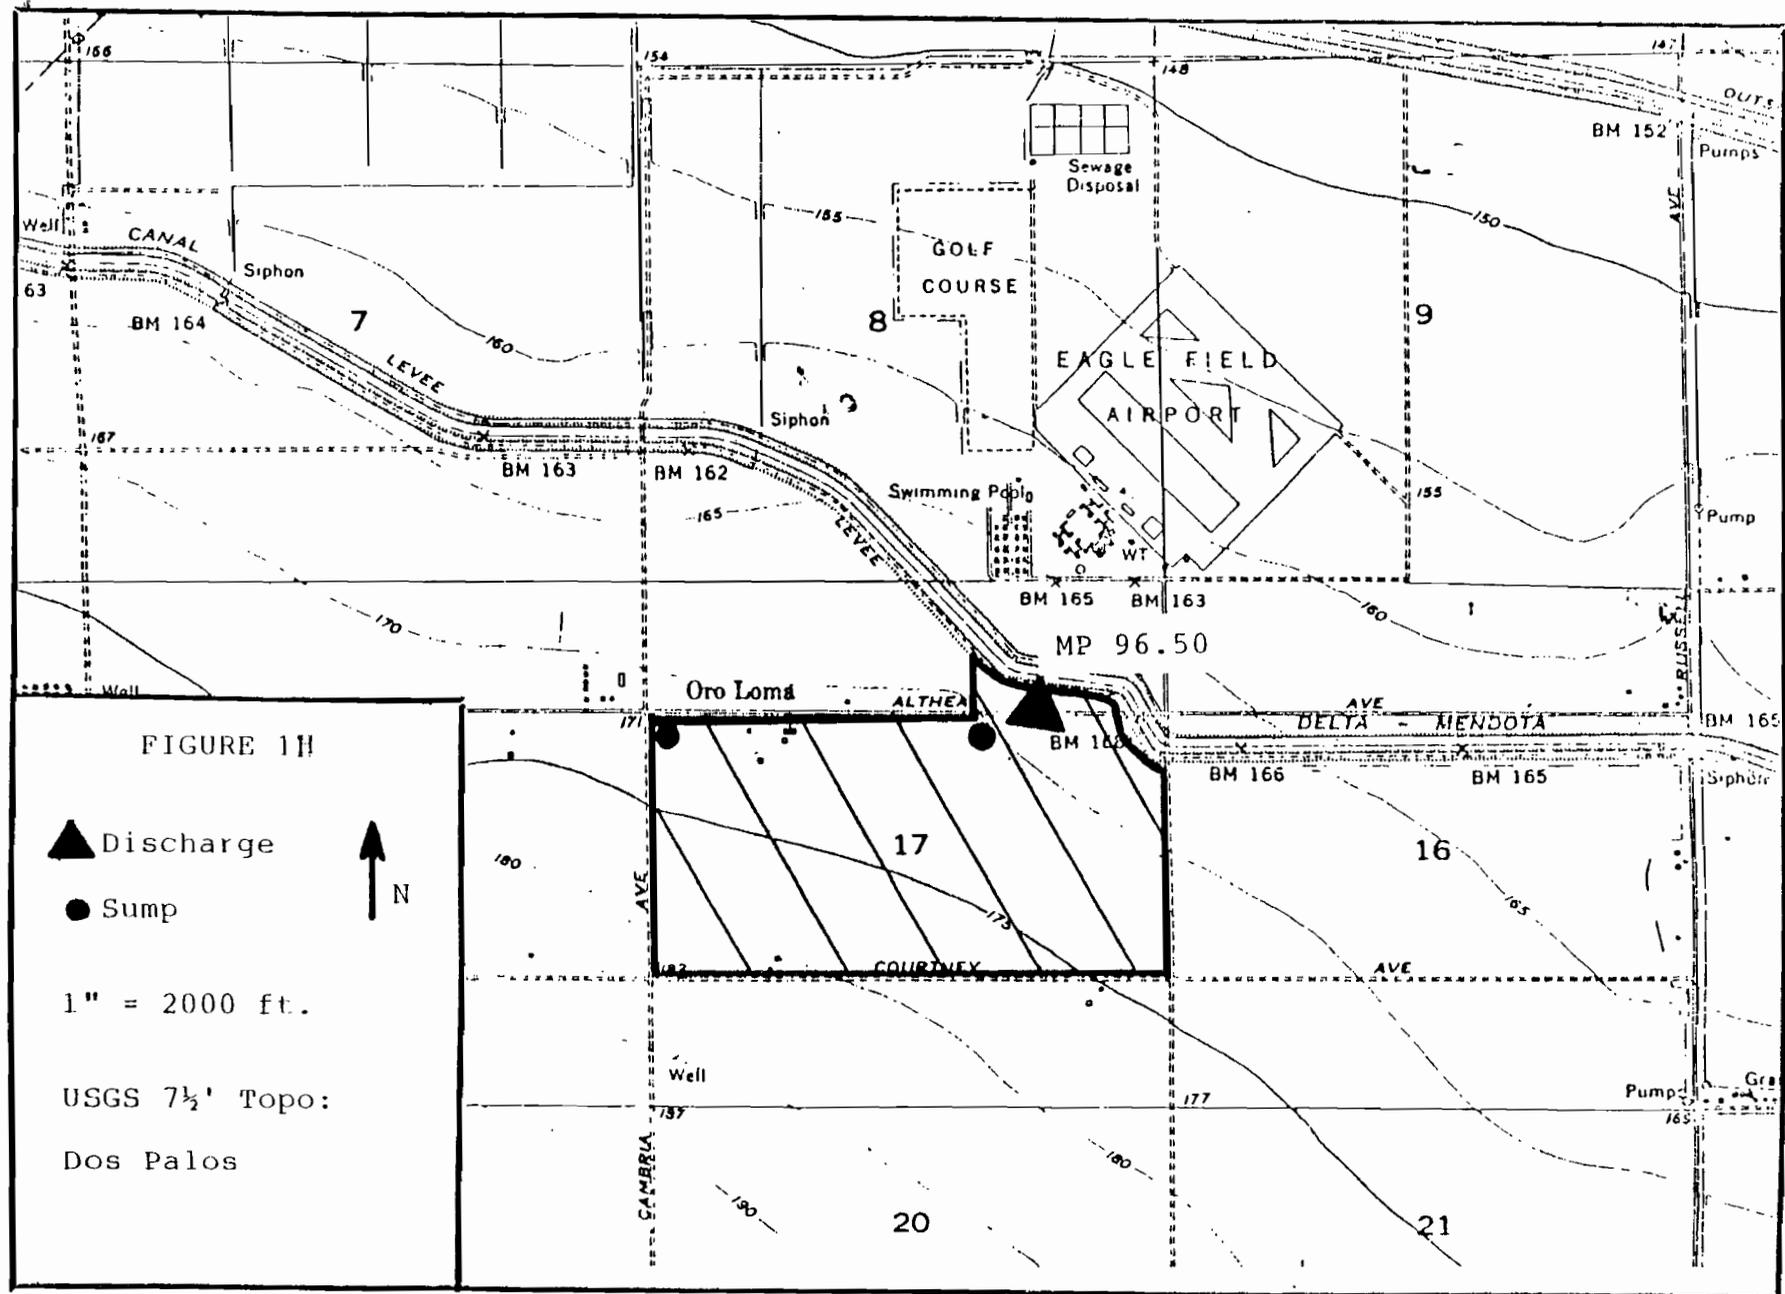
FIGURE 1H

Figures 1A through 1L present the estimated drainage areas for the check drains. Subsurface drainage sumps are also indicated on these figures. However, we feel the location of subsurface drainage sumps is incomplete. There are likely to be additional sumps in interior areas not easily accessed from public roads. This notwithstanding, we were able to identify 19 check drains as possibly receiving subsurface drainage. This was done on the basis of either location of a known sump in the drainage area or the finding of EC values above
